Bell 525 Flight Test Accident
Bell Helicopter Party Submission
DCA 16FA199

Bell Helicopter Textron Inc.
Bell 525 Serial Number 62001
N525TA

Italy, Texas
6 July 2016

Bell Helicopter Party Submission

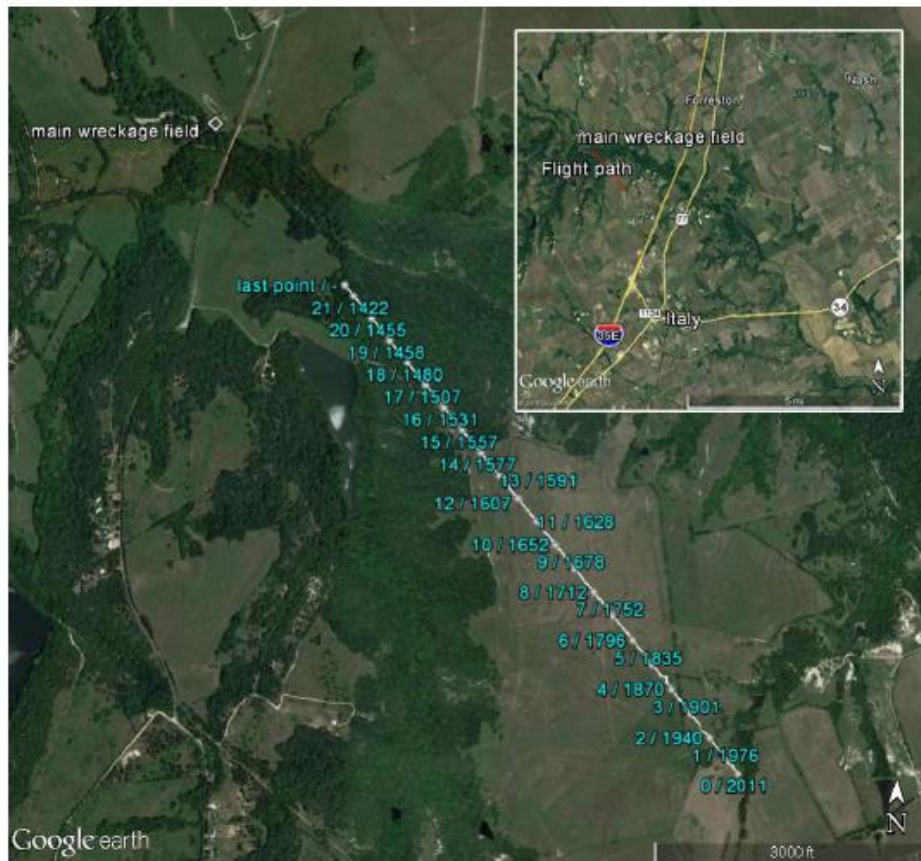
Figure 1 shows the test aircraft's flight path for record 51. Each point is annotated with the time in seconds from the start of record 51 and with the corresponding height above ground in feet. The test record began at time zero, in the lower right of the figure. The telemetry system stopped recording data at approximately the 21 second mark. The test aircraft's last verified position is shown as "last point" in Figure 1 (from Reference [1]).

Figure 1. Test Aircraft Flight Path and Wreckage Location. (image courtesy NTSB)

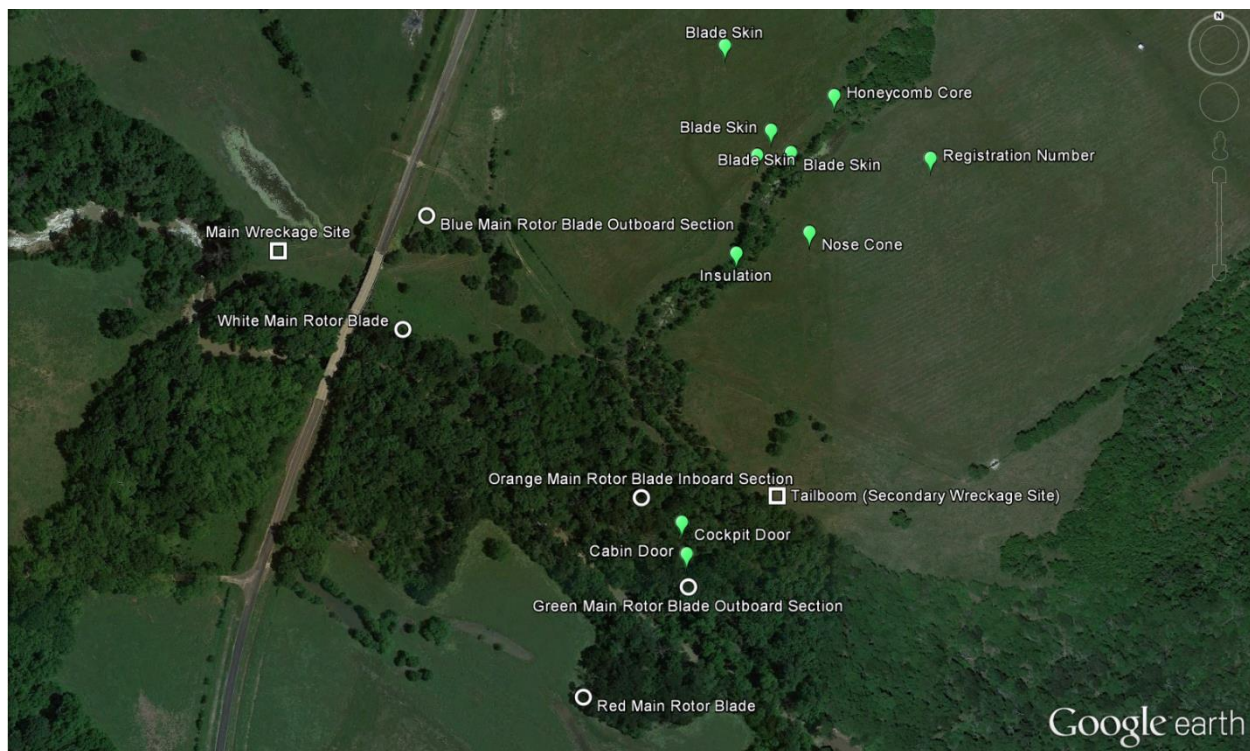
The main wreckage field was 2,200 ft from the last transmitted GPS point, along the flight path heading of 320°. The wreckage was distributed into two distinct areas. The main wreckage site was comprised of an impact crater, remnants of the main fuselage, cockpit, transmission and main rotor hub, two of the five main rotor blades, the forward portion of the tailboom, and both engines. There was evidence of a post-crash fire at the main wreckage site. The wreckage debris path at the main wreckage site, about 200 feet in length, was oriented along the 315-degree magnetic bearing. The second distinct wreckage site, about 1,300 feet southeast of the main wreckage site, comprised the aft portion of the tailboom. The aft portion of the tailboom contained two of the tail rotor drive shafts, the intermediate gearbox (IGB), tail rotor gearbox (TRGB), and tail rotor hub assembly with all four blades and dampers attached.

Figure 2. Accident Aircraft Debris Field. (image courtesy NTSB)

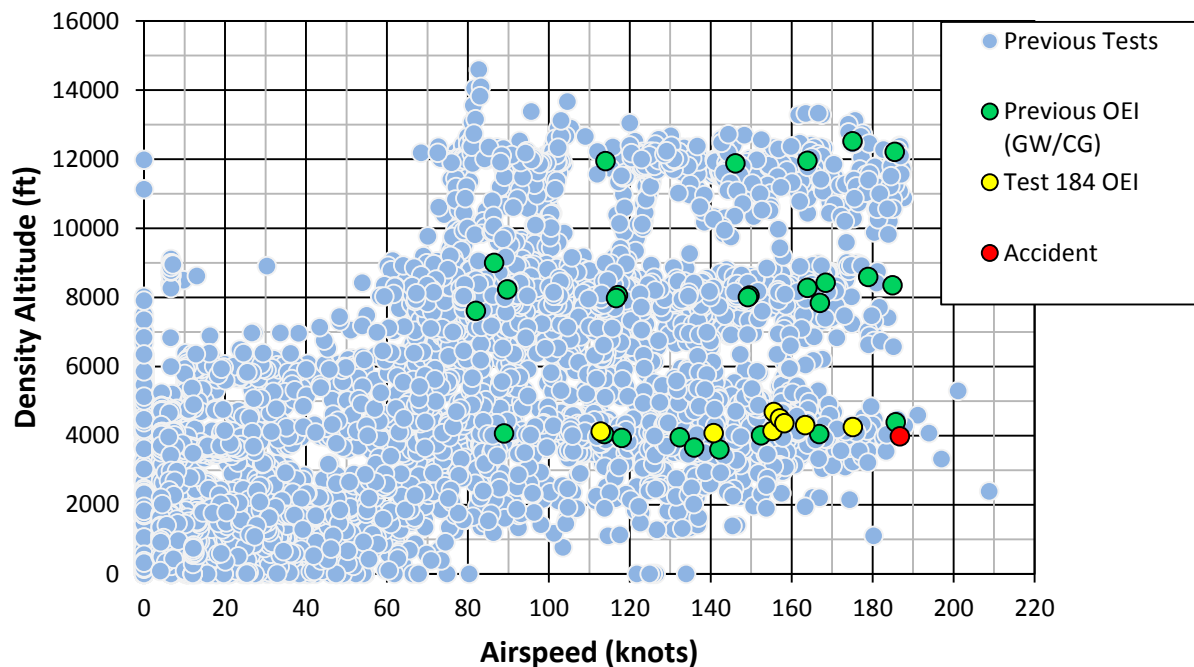
Simulated OEI testing at various altitudes and airspeeds had already been completed for two cases of aircraft loading (gross weight and center of gravity) as seen by the green points in . No anomalies were seen. The test aircraft was configured for heavy, forward cg loading on the day of the accident. Simulated single engine failure testing began at 4000 feet altitude for increasing airspeeds (10 knot intervals, beginning at 155 knots). Testing progressed to the final airspeed point for the given altitude when the accident occurred. The accident point is shown as the red dot in Figure 3.

Figure 3. Envelope expansion points completed up to Day of Accident included numerous simulated single engine failure test points (in green). The accident occurred on Test Flight 184, which included similar simulated single engine failure test points (yellow) and the accident test point, record 51 (red dot).

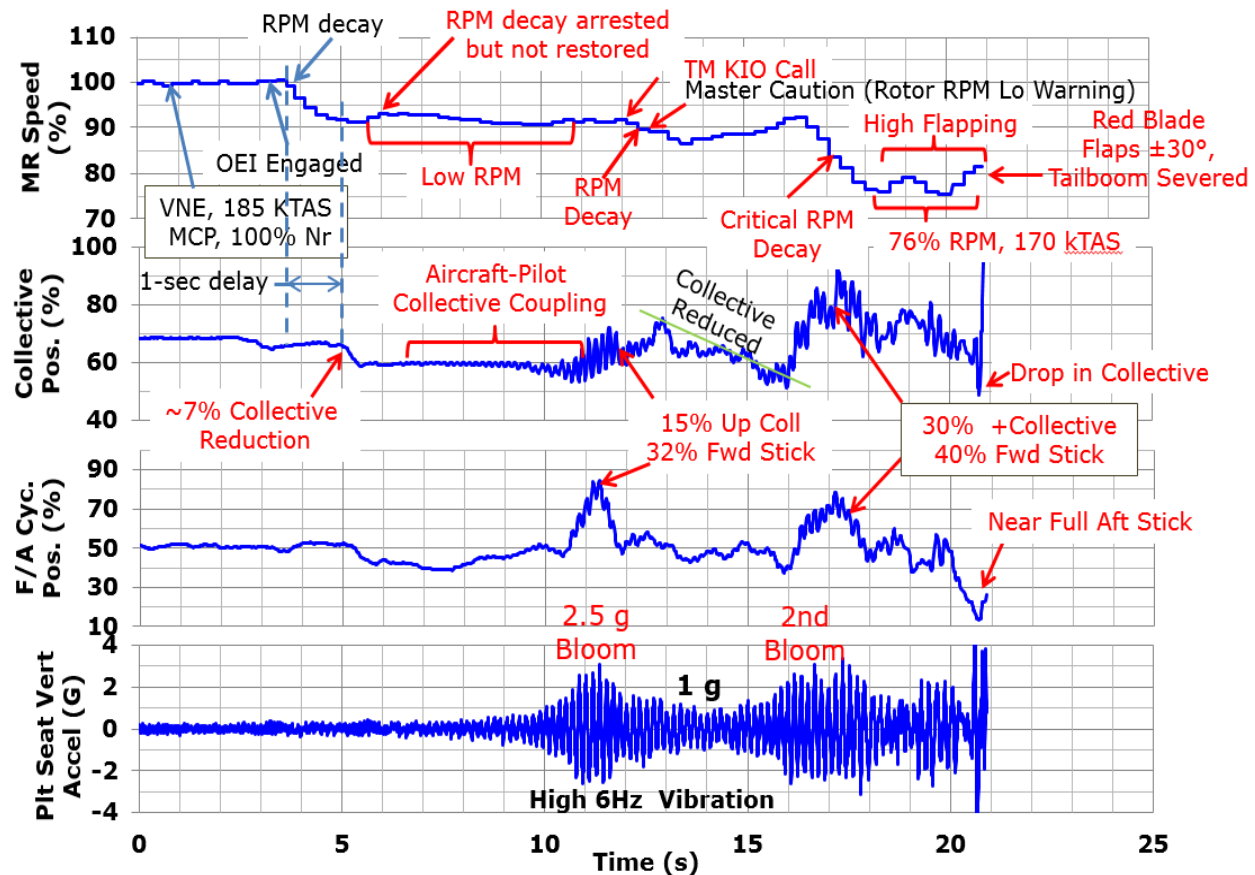
Figure 4. Time history of accident record, showing control inputs, rotor response, and pilot seat vibration level.

Still referring to **Figure 4**, while in the region labeled “Low RPM,” a further reduction in collective control might have been anticipated (to fully restore rotor RPM)². As discussed later, an in-depth analysis of the flight record shows that the sustained low rotor RPM was linked to the development of a main rotor dynamic mode and a feed-back loop that produced high vibration levels throughout the aircraft. Referring to the bottom plot in **Figure 4**, the vibration level sensed by the pilot seat accelerometer began to show vibration rising above the background

Referring to the collective control position in **Figure 4**, it is seen that the collective (while undergoing 6 Hz involuntary oscillation) also undergoes an increase in mean position (from 10.5 seconds to 11.5 seconds). It is believed that the mean increase in collective position is related to the pilot undergoing significantly increased vertical vibration, and the pilot may have been unaware of the command. Nevertheless, the increased collective position represents an adverse increased power requirement by the rotor. With only single engine power available, a reduction in RPM is evident in the main rotor (see the top of **Figure 4**).

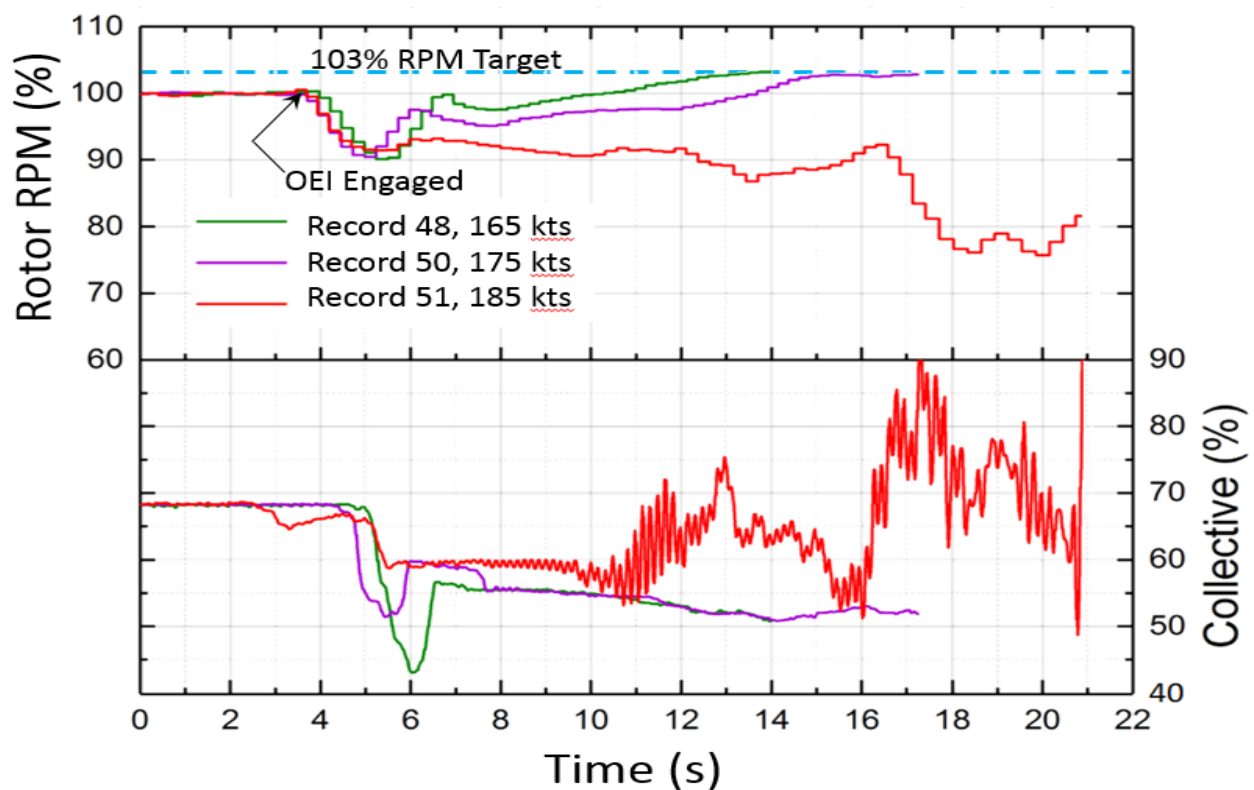
Figure 5. Completed test records 48 and 50, just prior to the accident record (51), showing rotor RPM recovery to 103% RPM with modulation of collective control.

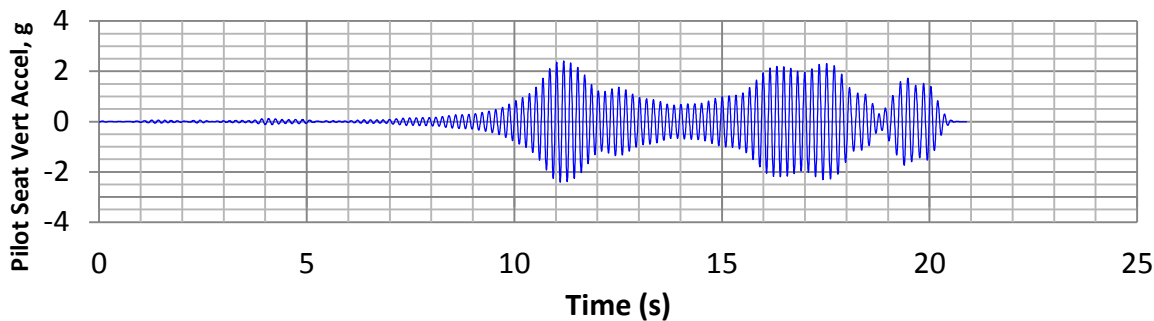
level at about 6.5 seconds. In Figure 6, a 6 Hz band pass filter is applied to the vertical vibration signal to highlight the predominant 6 Hz frequency of the vibration. In referring to the second subplot of **Figure 4** (labeled “Aircraft-Pilot Collective Coupling), the vertical vibration of the pilot seat generated an involuntary 6 Hz biomechanical oscillatory motion of the collective control position that further amplified the vibration level and (with other factors discussed later) resulted in the first vibratory bloom (labeled “2.5g bloom”) in the lower subplot of **Figure 4**. The 2.5g vibration bloom (at 11 seconds and again at ~17 seconds) was nearly 40 times the normal vibration level seen in the experimental aircraft.

Figure 6. Pilot seat vertical vibration with band pass filter showing 6 Hz signal content.

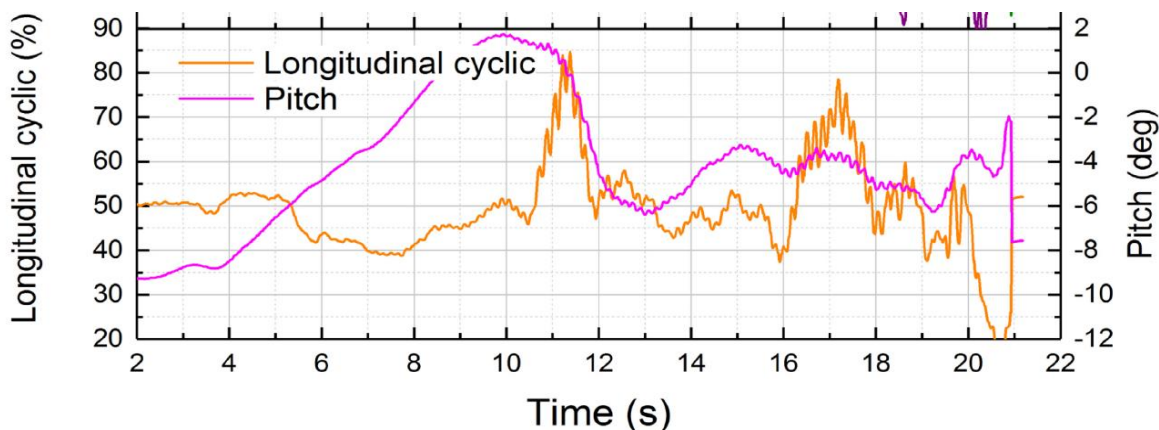
While the mean collective increase is likely involuntary, the forward cyclic applied between 10.5-12 seconds appears to have been a deliberate input. While counterintuitive to the recovery, the forward cyclic input may have been an attempt to bring the aircraft to a nose down pitch attitude that existed earlier in the maneuver when the vibration was low³. Pitch attitude, shown in Figure 7, indicates that the maneuver was entered in a slight dive (~9 degrees nose down just prior to the 4-second mark). There was no particularly noticeable vibration in the dive, but at the 10 second mark, when the vibration had become excessive, the pitch attitude was approximately 2-degrees above the horizon. As seen in **Figure 4**, the vibration levels were reduced noticeably (but were still high) after the forward control input, but for different reasons that will be discussed later.

Figure 7. Aircraft pitch attitude change (right Axis) coincided with increased vibration and may have led the pilot to apply forward cyclic during the accident record.

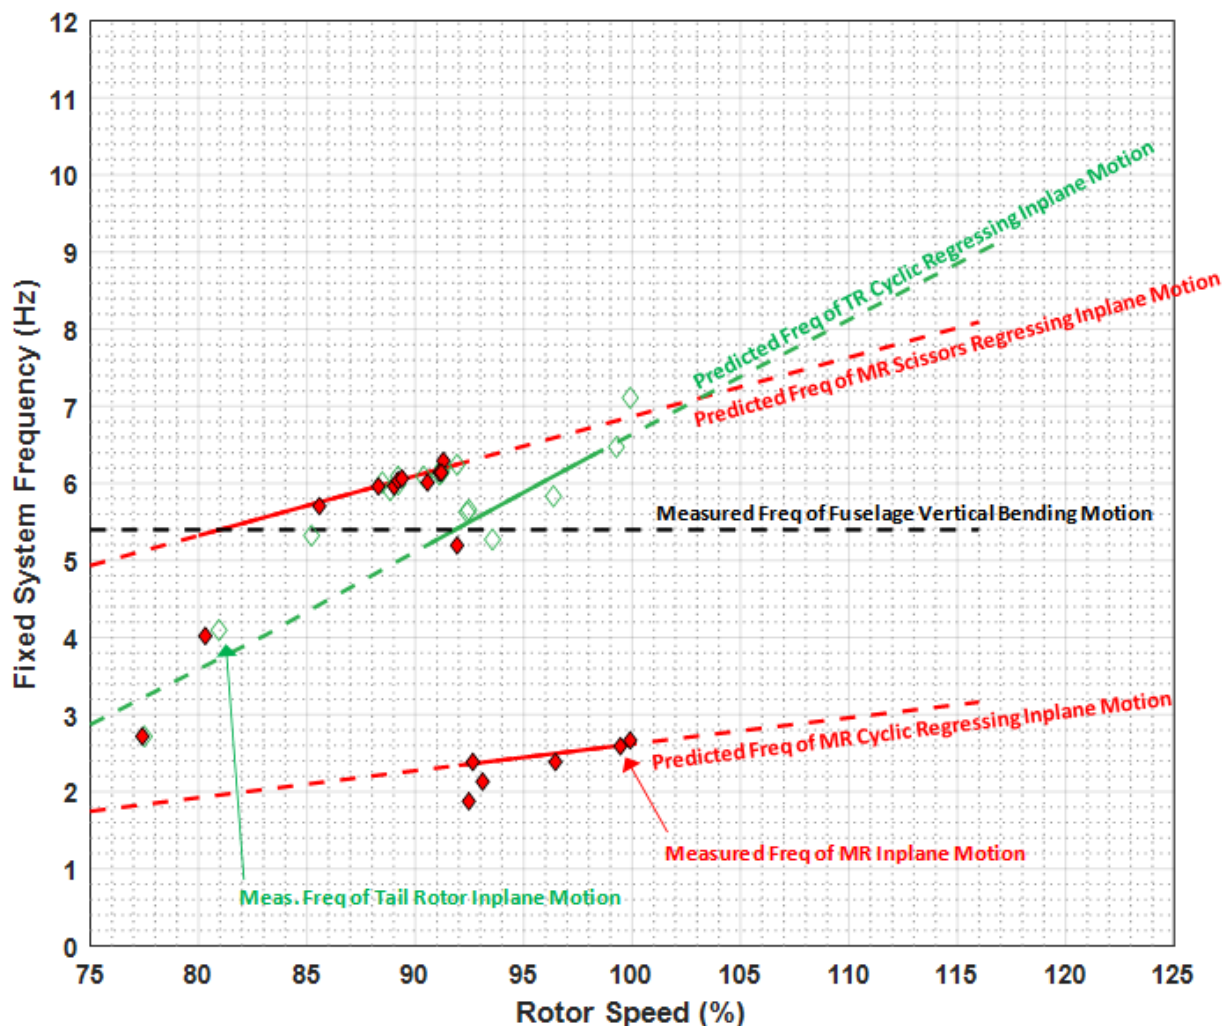
Frequencies of the main rotor and tail rotor modes of interest are shown in terms of the non-rotating (fuselage fixed) reference frame in Figure 8. The airframe first vertical bending mode frequency is also shown by the dashed horizontal line. Since fixed system rotor mode frequencies are a function of rotor RPM, the rotor modes have a slope, whereas the airframe represents a non-rotating structure, unaffected by rotation, and does not change with RPM. Figure 8 does not assign amplitude to any of the modes and only shows the modal frequencies. Referring first to the tail rotor, the accident record indicates that the tail rotor cyclic regressing mode was the predominant tail rotor “blade pattern” as the rotor decelerated to 93% RPM. At the same time, the main rotor’s cyclic regressing mode (near 2.4 Hz) was the dominant pattern⁴. The airframe first vertical bending mode frequency (verified by airframe vibration tests) was near 5.4 Hz.

Figure 8. Airframe, Main Rotor, and Tail Rotor dynamic modes predicted and measured during the accident record.

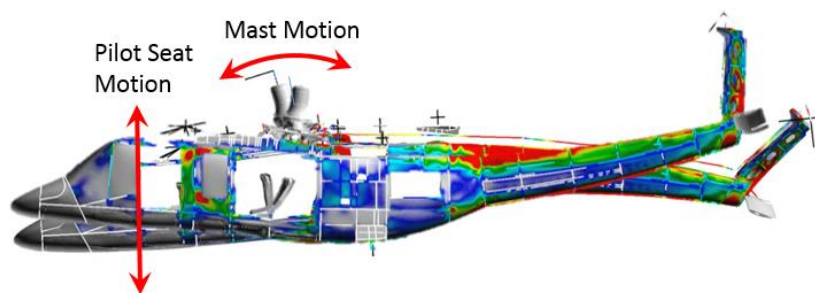
The vertical bending mode of the airframe includes fore/aft pitching motion of the main rotor mast and vertical/lateral motion of the forward cabin. The motions of the airframe are illustrated in Figure 9, which shows (in highly exaggerated displacement) an overlay of the airframe at its minimum and maximum displacement for the first vertical bending mode. The forward part of the cabin (which includes the pilot seat and the attitude heading reference systems) sees mainly 6 Hz up-down vertical motion. In contrast, the response of the main rotor mast to fuselage bending is primarily fore/aft pitching. With reference to the main rotor tip path plane (not shown), the mast's fore/aft pitching motion is equivalent to the application of fore/aft cyclic. At high forward speed, cyclic control inputs of this nature constitute a stimulus for the main rotor scissors mode.

Figure 9. Illustration of the airframe first vertical bending mode (with highly exaggerated displacement) shows the forward cabin motion as primarily up and down, while the main rotor mast pitches fore/aft.

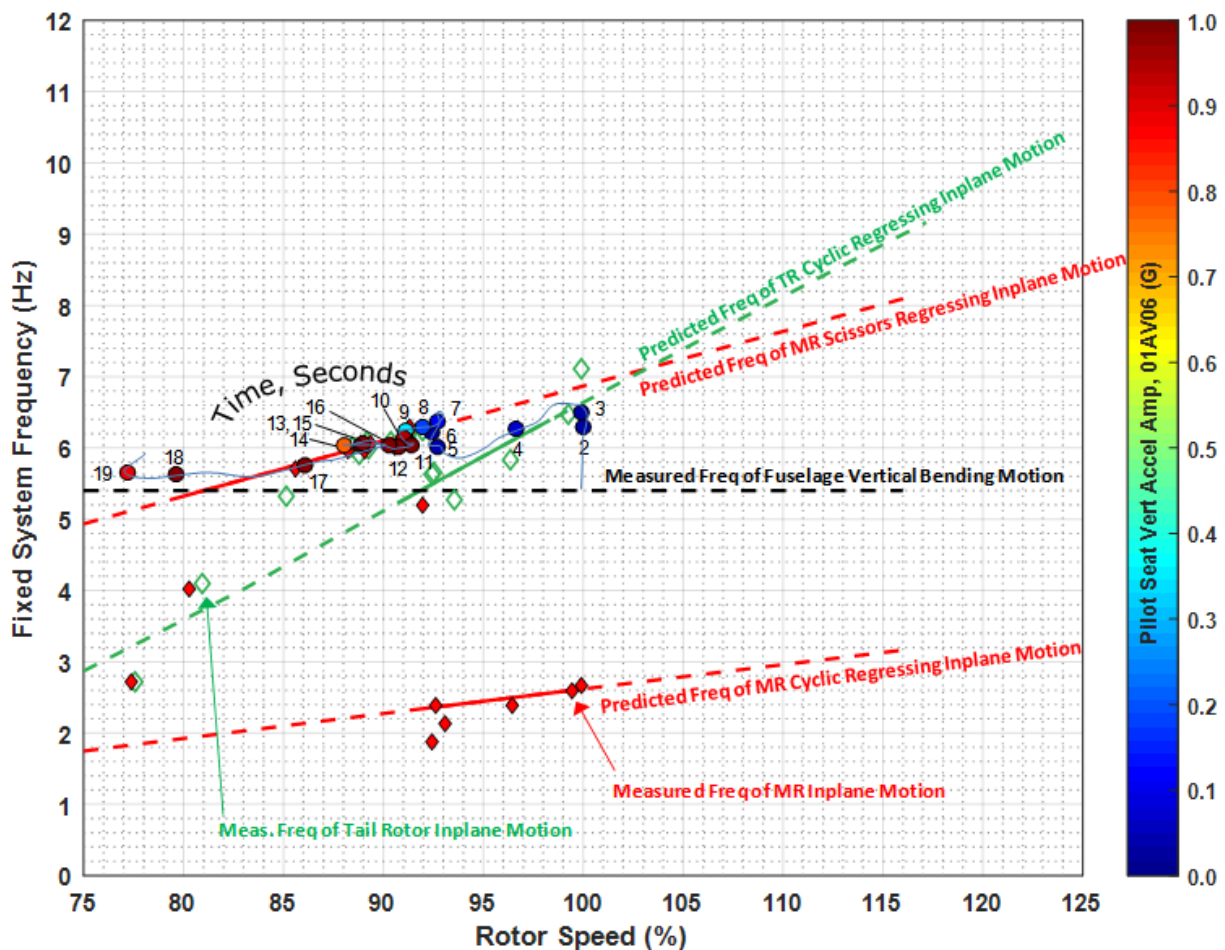
Figure 10. Modal frequencies of the Airframe, Main Rotor, and Tail Rotor with amplitude of Pilot seat vertical vibration.

Figure 10 shows that the ~6 Hz main rotor scissors mode is the predominant rotor pattern at approximately 6.5 seconds into the accident record. Pilot seat vibration is low at 6.5 seconds but the scissors mode feeds a low amplitude ~6 Hz vibration through the airframe bending motions. Aerodynamics of the scissors mode produces a fore/aft forcing of the main rotor hub at the scissors mode frequency. Fore/aft motion of the hub, in turn, transfers mast pylon rocking motion to the airframe resulting in 6 Hz vertical motion at the pilot seat and at the location of the Attitude Heading Reference System (AHRS) in the forward cabin. Airframe vertical bending couples with airframe lateral bending and some lateral 6 Hz motion is also produced in the airframe.

As shown in Figure 10, the 6 Hz pilot seat vibration begins at low amplitude, (beneath the normal background vibration level). The fore/aft hub forcing, airframe bending, pilot seat motion and AHRS motion form a closed loop feedback path that amplifies the 6 Hz vibration

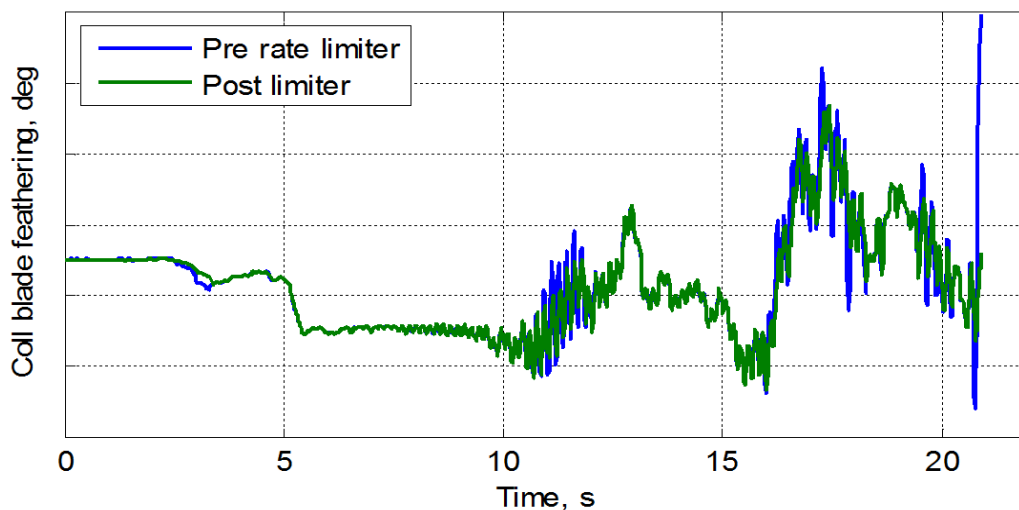
There were several instances in the accident record where the pilot collective oscillation was attenuated by collective rate limiting. At times where the vibration was the highest (11.5 seconds and 17.5 seconds in **Figure 4**), the biomechanical collective motion produced collective rates that exceeded a prescribed limit in the control laws. Figure 11 shows the effect of collective rate limiting. The green curve represents the rate-limited collective control that was applied to the main rotor actuators during the accident record. Without rate limiting, the larger cycles of the blue curve would have been sent to the main rotor actuator. By comparing Figure 11 with Figure

4 (Pilot seat vibration), it is seen that when collective rate limiting was in effect, the diverging vibration blooms reverted to lower vibration levels. The rate limiting appears to damp the feedback cycle, reducing the vibration level from 2.5g to 1g shortly after 11.5 seconds and again at 17.5 seconds. It is believed that since the damping of vibration coincided with the forward cyclic and positive collective at 11.5 seconds, the pilot may have associated the vibration reduction with those control inputs. This “negative training” may explain the second application of forward cyclic control and positive collective during the second vibration bloom at 17 seconds (assuming the pilot was attempting to reduce vibration levels).

Figure 11. Biomechanical feedback of the collective control is inhibited by collective rate limiting enforced by the control laws. Rate limiting reduced the oscillatory collective input applied at the main rotor actuators and appeared to dampen the feedback cycle, reducing pilot seat vibration.

As the 525 flight test program continues its development, the design will incorporate a new collective control filter that targets vibration frequencies near the 6 Hz band. Existing filters in the cyclic control are tuned and deepened, as are the rate filters in the AHRS system. Enhanced closed loop system modeling shows that these filter changes would result in a damped response that attenuates control system feedback and stabilizes cabin vibration throughout the flight envelope (and outside the flight envelope where the steady 92% RPM led to the amplification of the main rotor scissors mode). Evaluations of the new filters in the 525 flight simulator indicate that the impact of the filters is detectable from a handling qualities perspective, but not objectionable.
